IMPORTANT PRODUCT INFORMATION

Product: PACSystems™ RX7i CPUs with Firmware Version 1.61

IC698CPE010-CD (300 MHz)

IC698CPE020-CD (700 MHz)

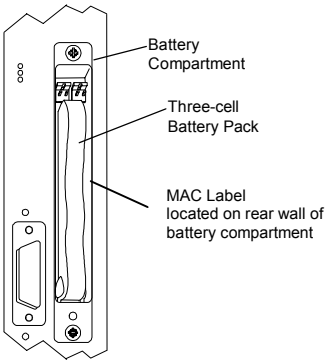
<i>Subject</i>	<i>Description</i>
MAC address	<p>A label on the rear wall inside the CPU's battery compartment identifies the MAC address assigned to the CPU's embedded Ethernet Interface. The label is visible when the battery is removed from its compartment. (The battery does not need to be disconnected to temporarily remove it from the compartment.)</p>

<p>The diagram shows a vertical battery compartment. At the top is the 'Battery Compartment' cover. Below it is a 'Three-cell Battery Pack'. On the rear wall of the compartment, there is a 'MAC Label'.</p>
Configuration of IP Address is Required Before Using Ethernet Communications	<p>The Ethernet Interface within the CPU module cannot operate on a network until a valid IP address is configured. The necessary Ethernet addressing information must be configured prior to actual network operation, or to recover from inadvertent changes to the Ethernet addressing data at the Ethernet Interface. Use one of the following methods to initially assign an IP address:</p> <ul style="list-style-type: none"> ■ Connect a serial terminal to the Station Manager port of the PACSystems RX7i . Then use the CHSOSW command to enter the desired IP address. For details, see <i>Station Manager for the PACSystems RX7i</i>, GFK-2225. ■ Temporarily assign an IP address to the module using the SetIP tool over the Ethernet network. For details, see <i>TCP/IP Ethernet Communications the PACSystems</i>, GFK-2224. ■ The Ethernet Interface automatically obtains a temporary IP Address from a BOOTP server on the network. For details, see <i>TCP/IP Ethernet Communications for PACSystems</i>, GFK-2224. <p>Once a temporary IP address has been set up, the Ethernet Interface can be accessed over the network (such as by the CIMPLICITY ME programming software). The programmer should then be used to configure the proper IP address for the Ethernet Interface.</p>
